SEWER INTERCEPTOR PROJECT

Public Meeting

September 25, 2018

Sanitary Sewer Repair-Rehabilitation Project

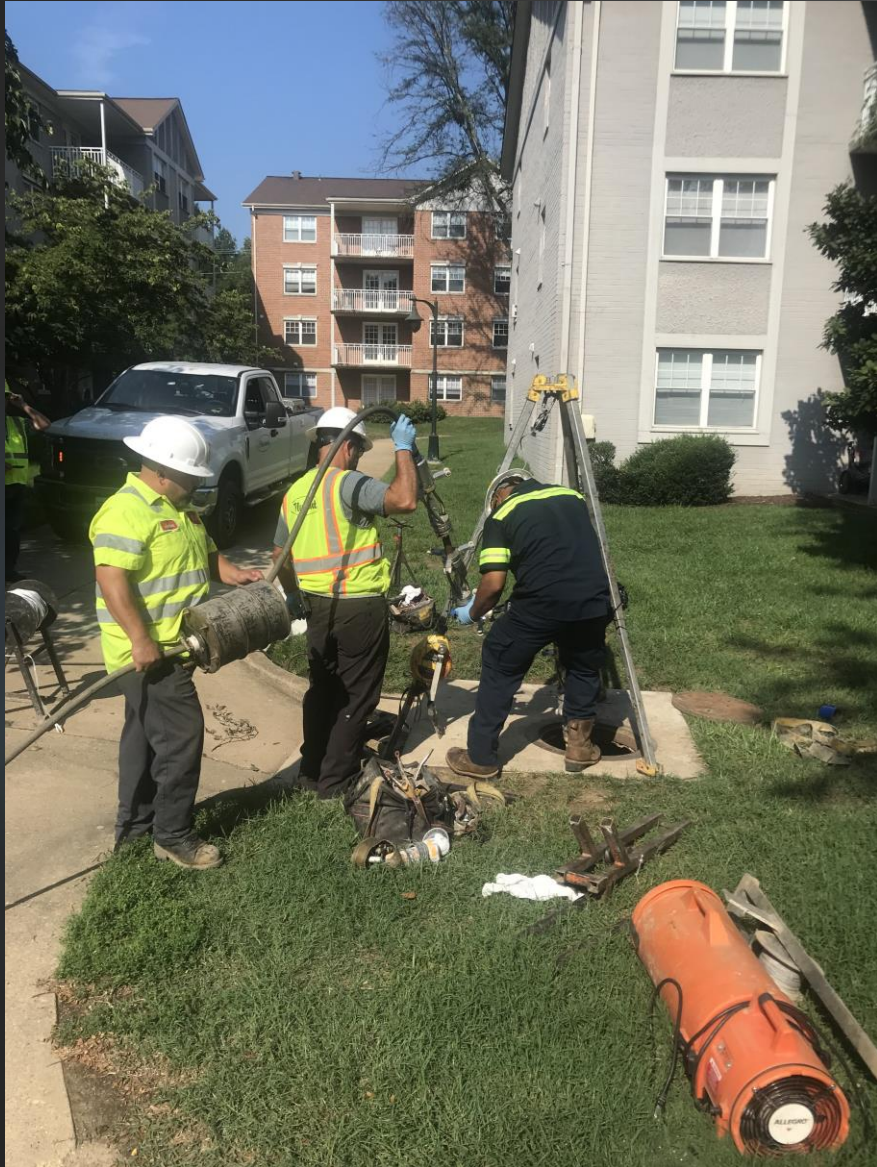
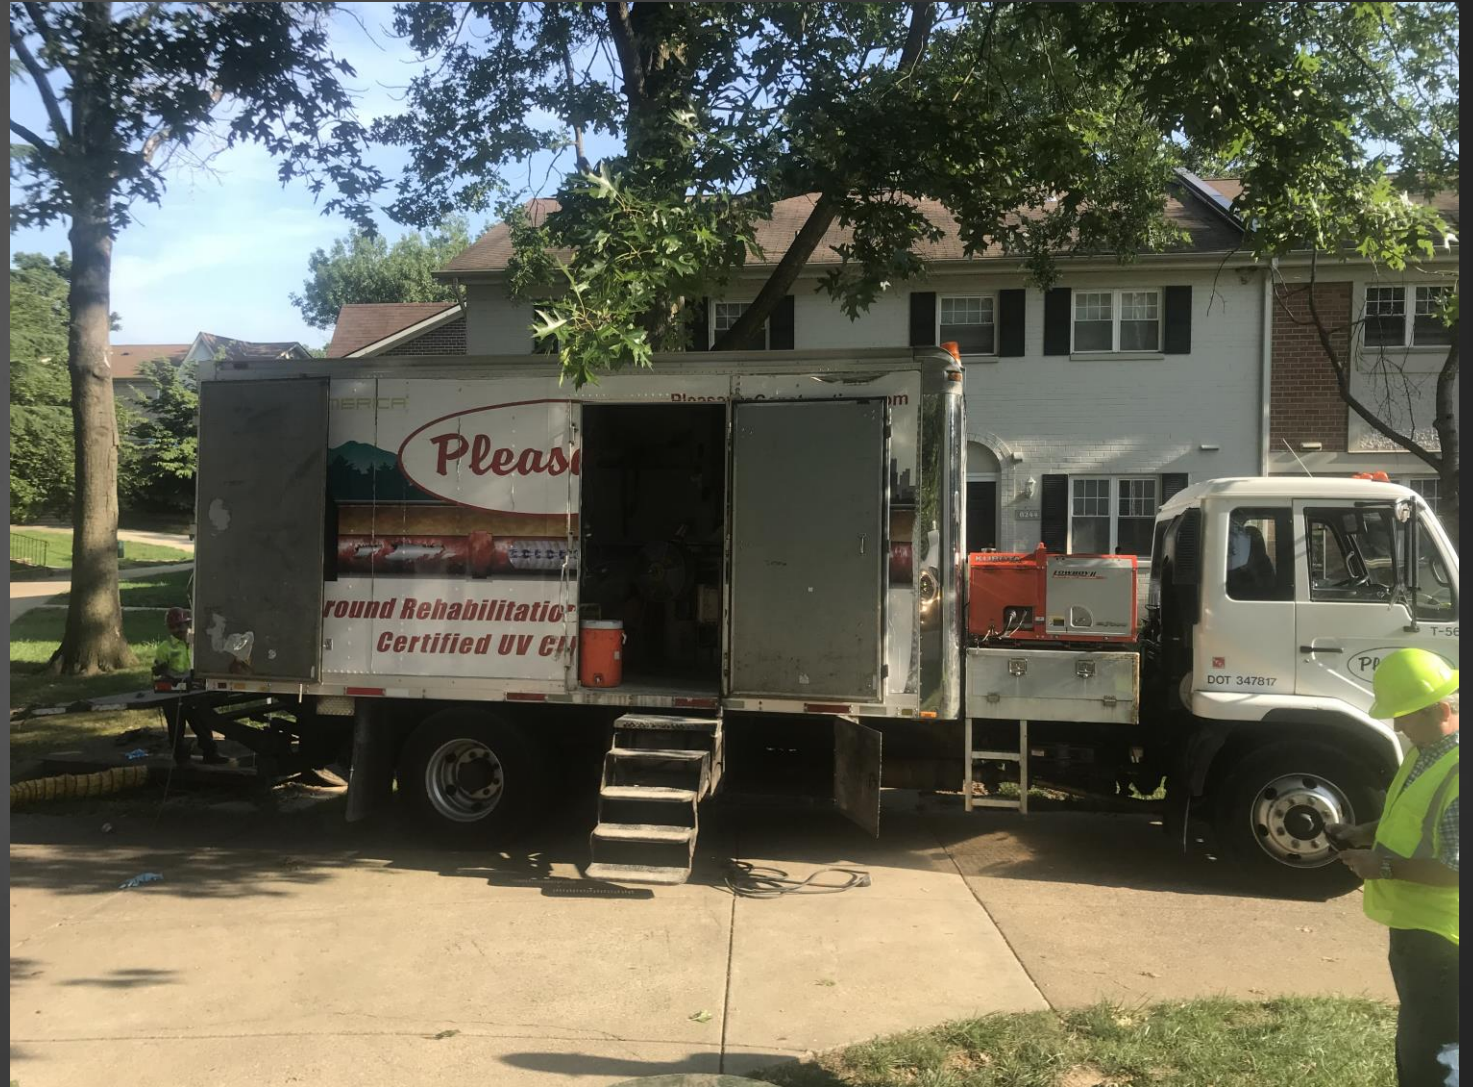
Cured-In-Place Pipe (CIPP)

- ▶ Trenchless Rehabilitation Methods:
 - ▶ Cured-In-Place Pipe
 - ▶ Thermoformed PVC
 - ▶ Spiral Wound PVC

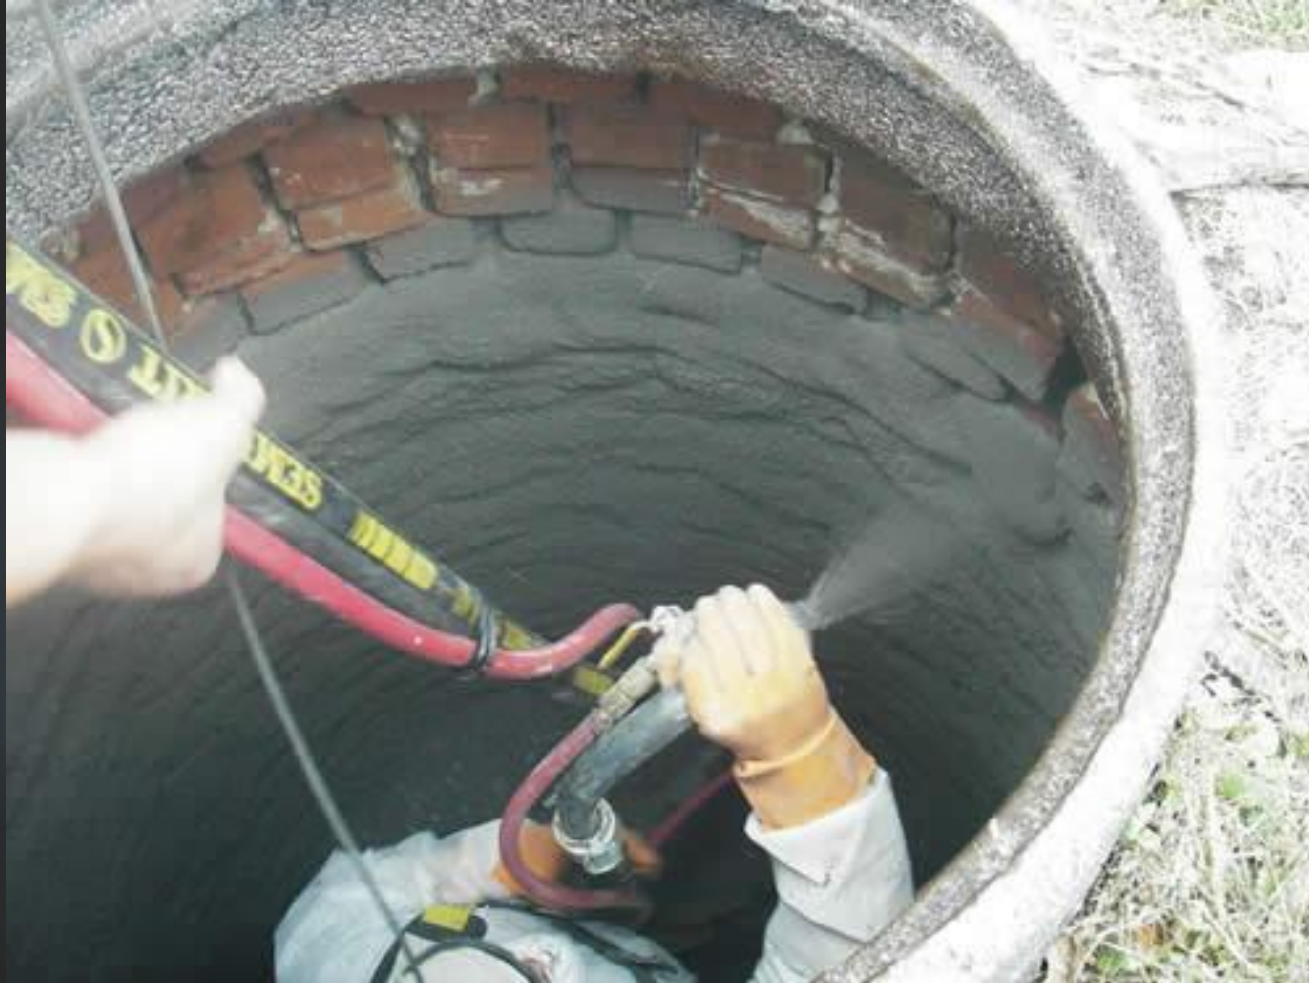
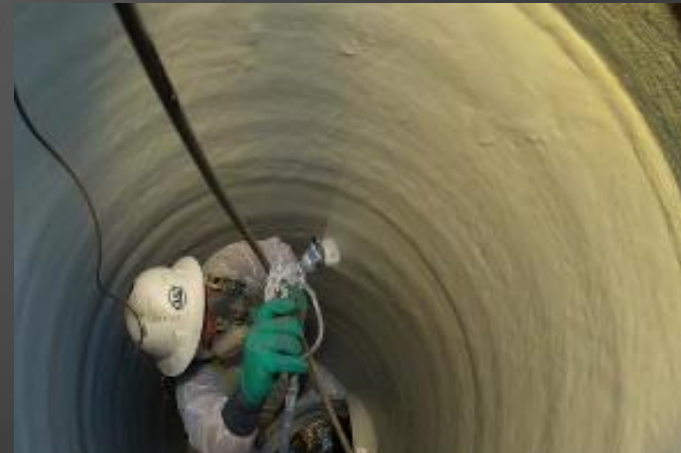
Manhole Restoration

- ▶ Minimize replacement of manholes (less excavation)
- ▶ Improve accessibility for maintenance
- ▶ Reinforce structural integrity
- ▶ Prevent infiltration and inflow

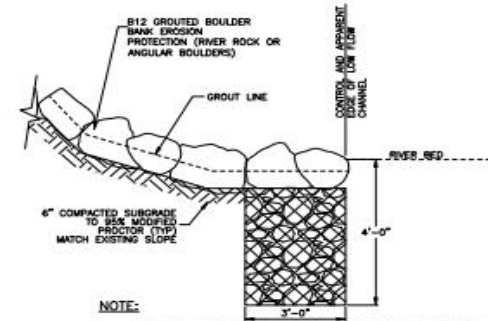
GRADED BOULDER THICKENED EDGE DETAIL

SECTION - A

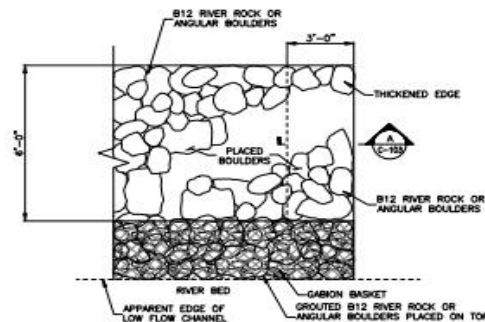
TYPICAL GROUTED BOULDER BANK EROSION PROTECTION SECTION

SCALE: HORIZ. 1"=5'
VERT. 1"=5'

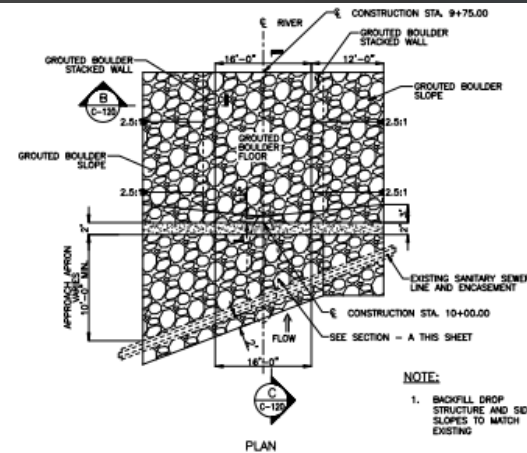
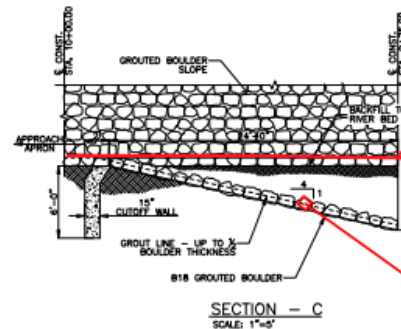
GRouted BOULDER DROP STRUCTURE (GBDS)

Backfill to Restore to
Existing Riverbed
Elevation

18" Grouted
Boulder Run
Down
