Public Meeting

December 4, 2018

RUIDOSO SEWER PROJECT

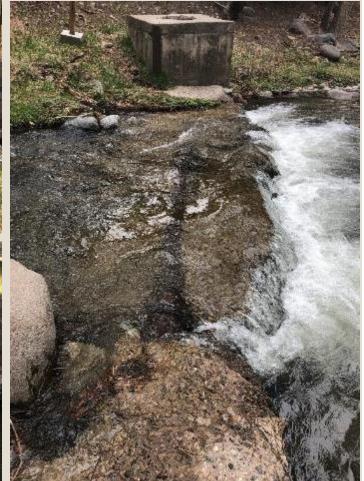
Exposed Sewer Crossings

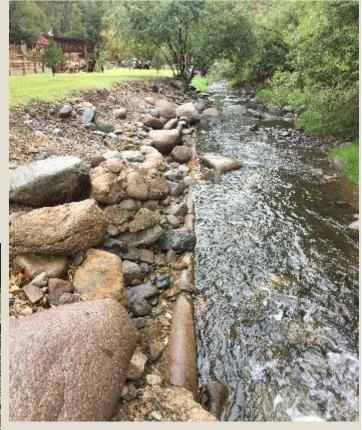
Exposed Sewer Crossings

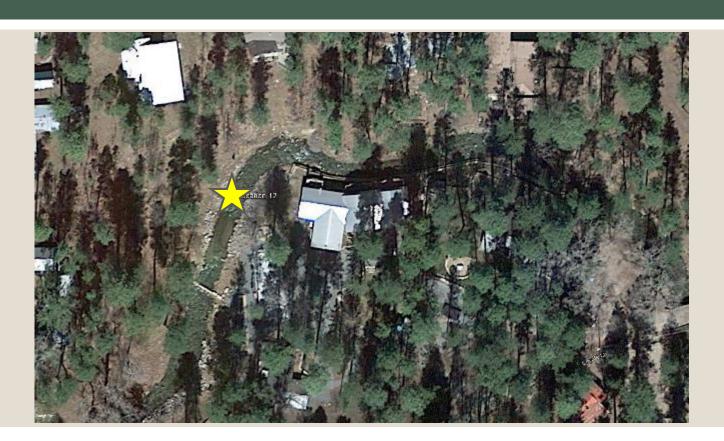
LOCATION 12 - AFTER

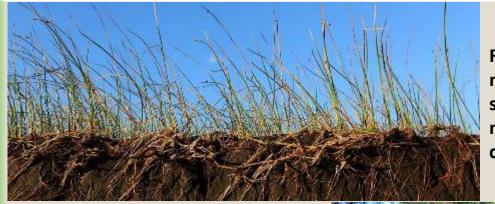
PLANTINGfor Bank
Stabilization

Roots of established native plantings hold soils in place and help mitigate bank destabilization

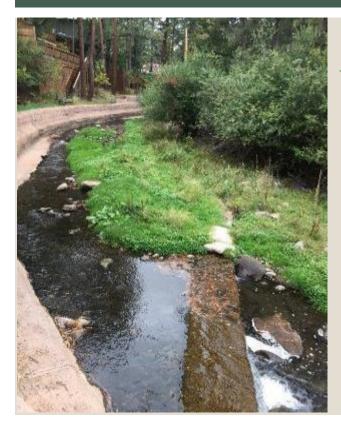
Location A

- This location will be armored
- The existing structure or wall, will remain
